United States Fire Administration

Technical Report Series

The East Bay Hills Fire Oakland-Berkeley, California

Investigated by: J. Gordon Routley

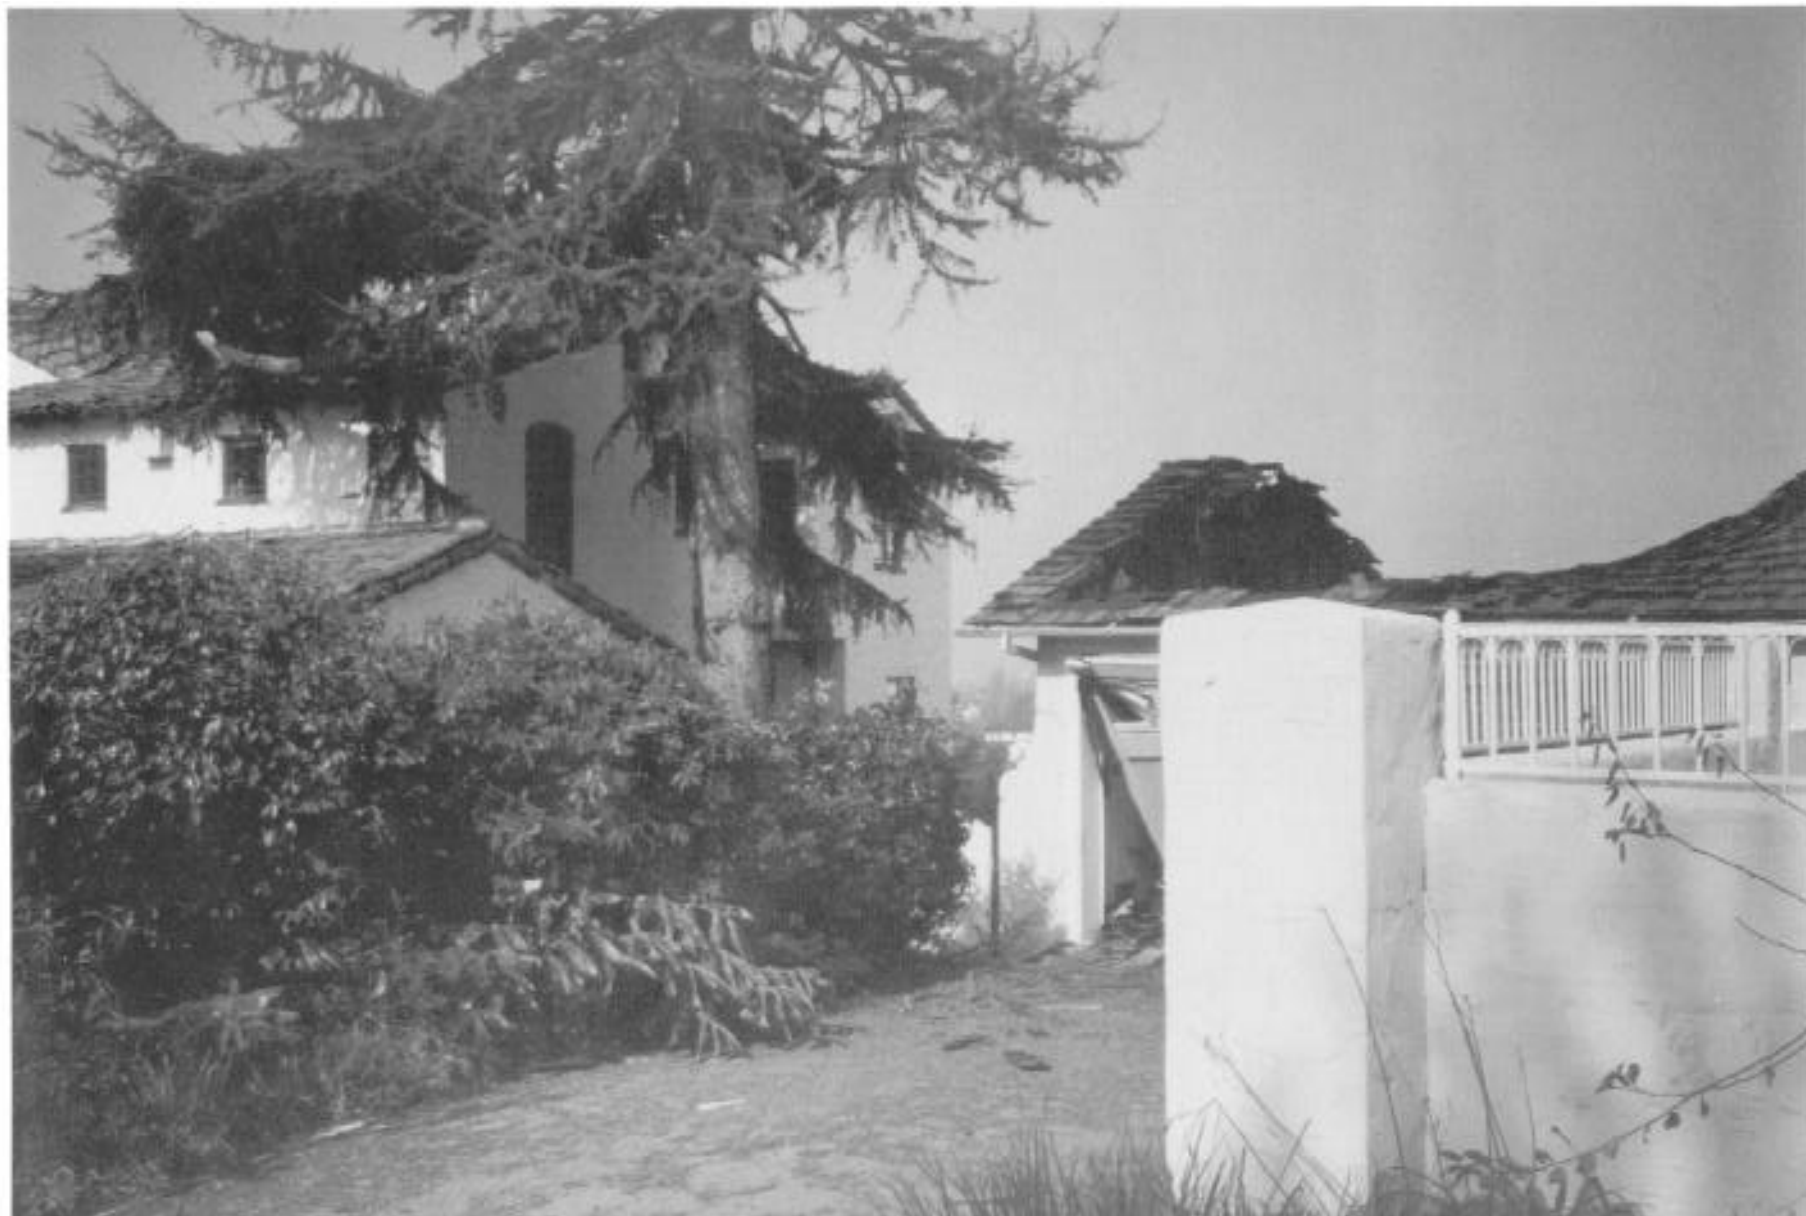
Home with wood shingle roof destroyed. Neighboring home with tile roof saved.

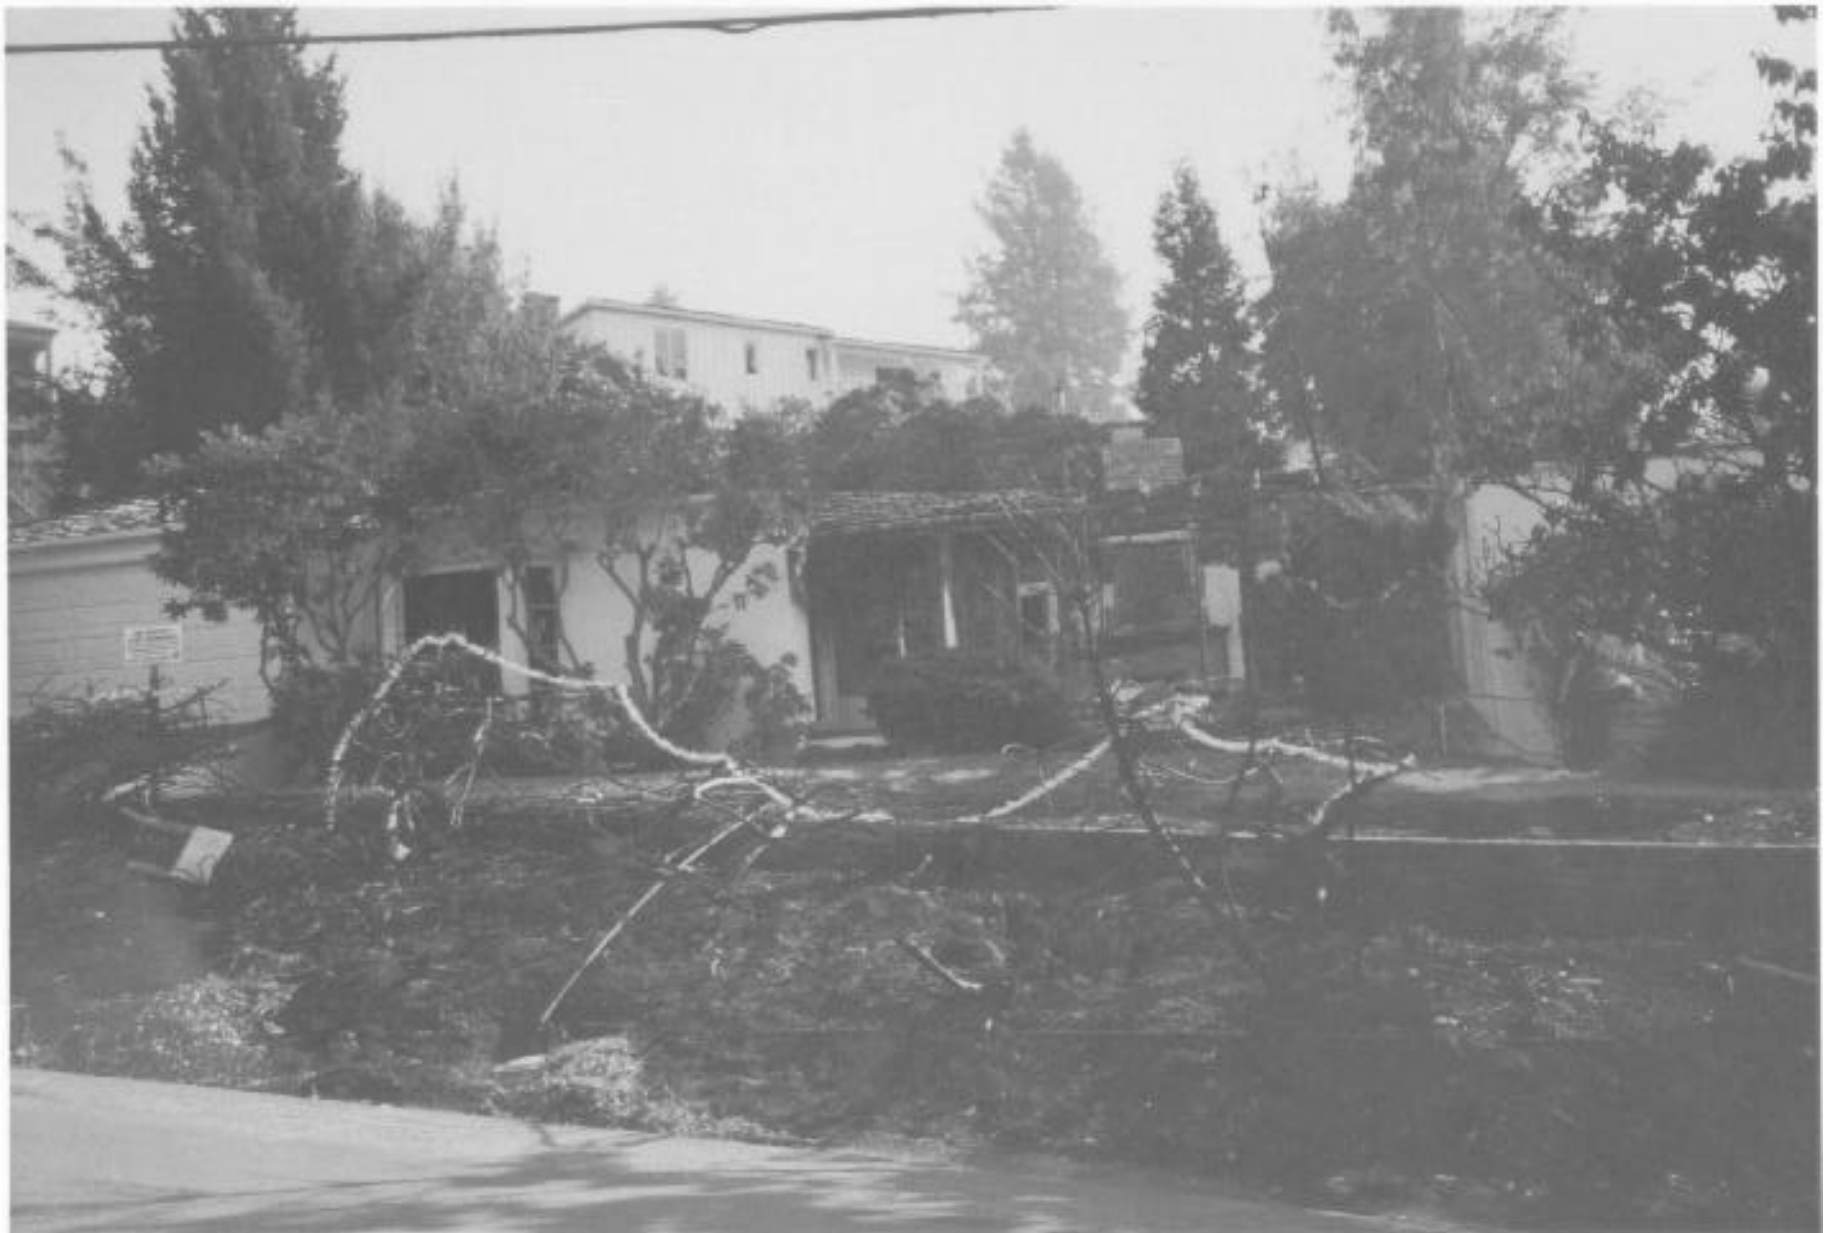
Home with wood roof burned off.

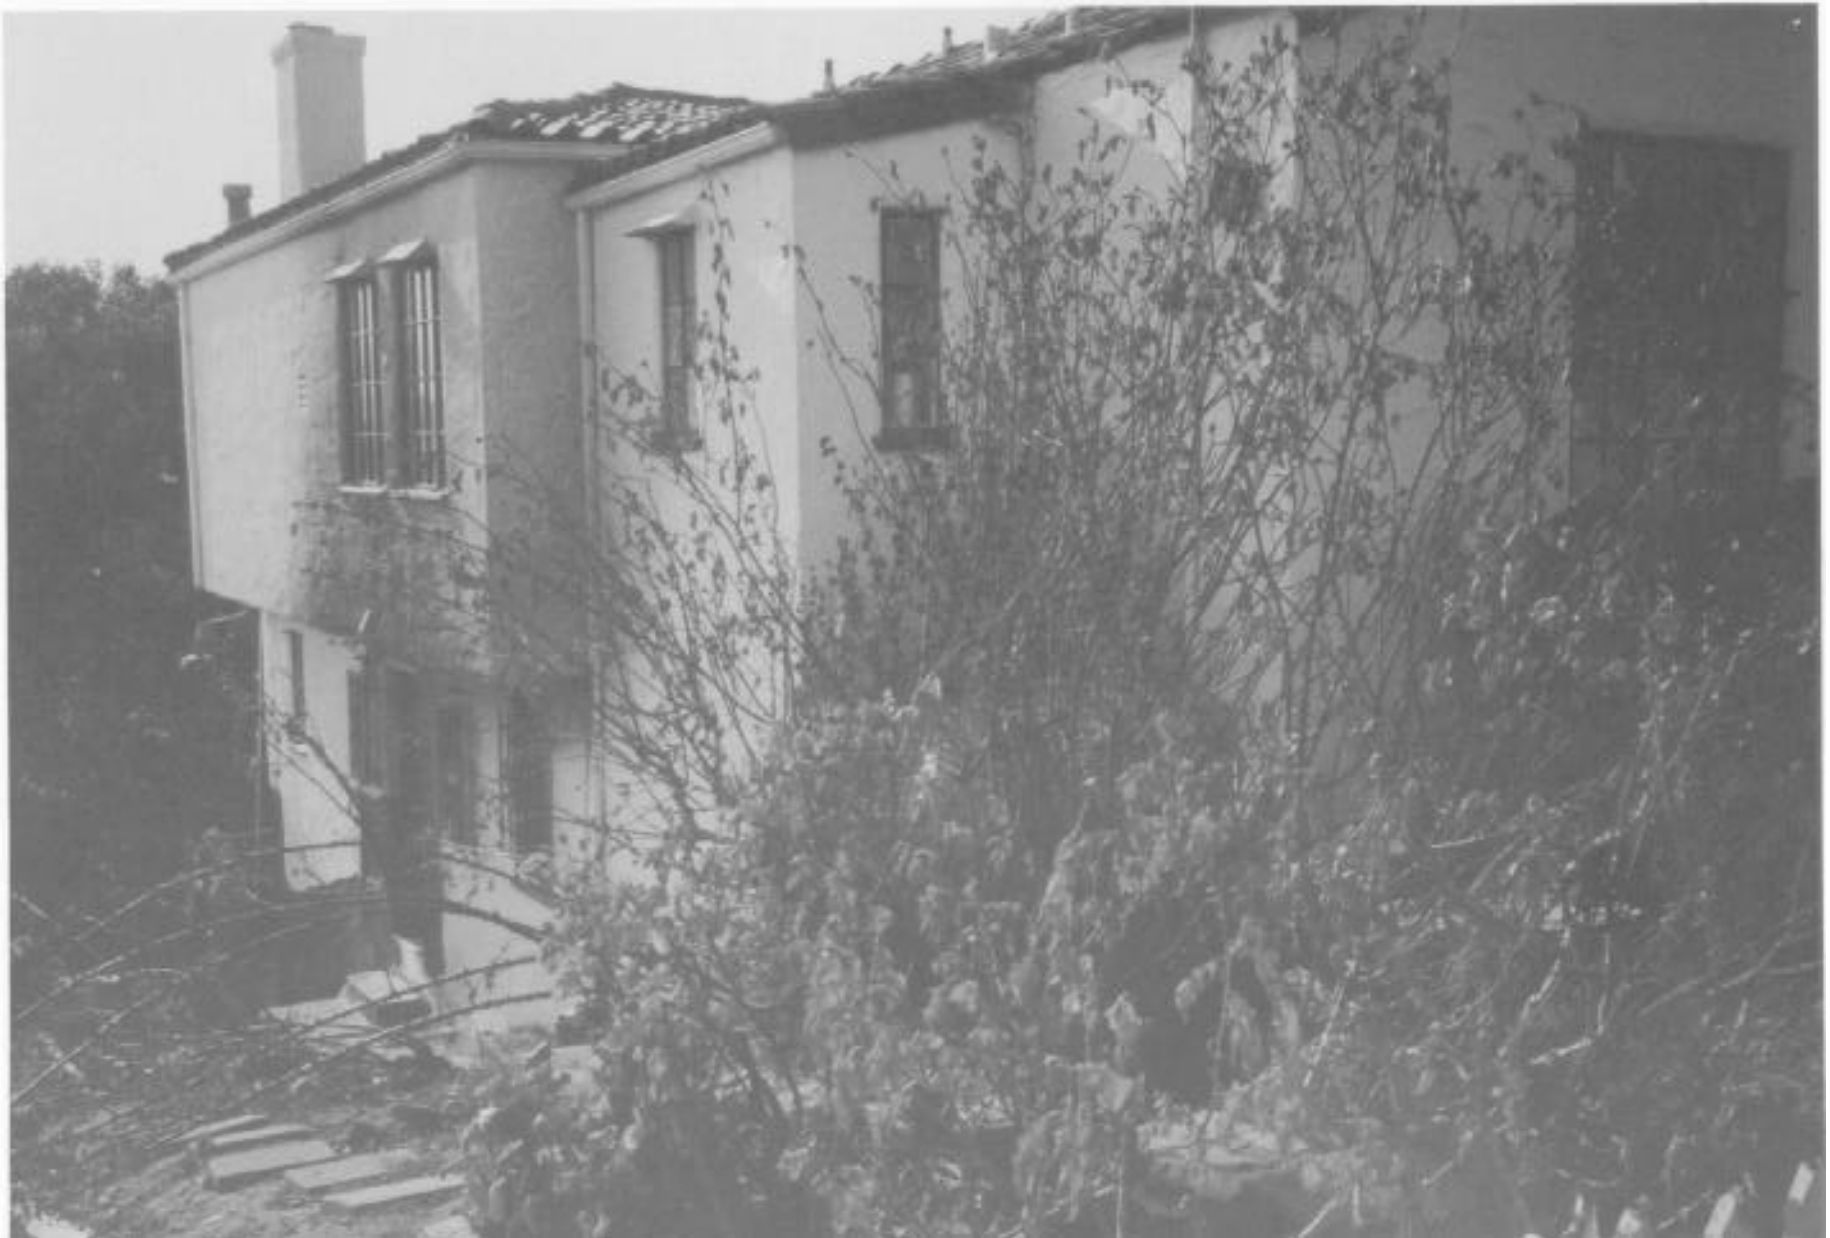
Large home saved by firefighters after vegetation became involved.

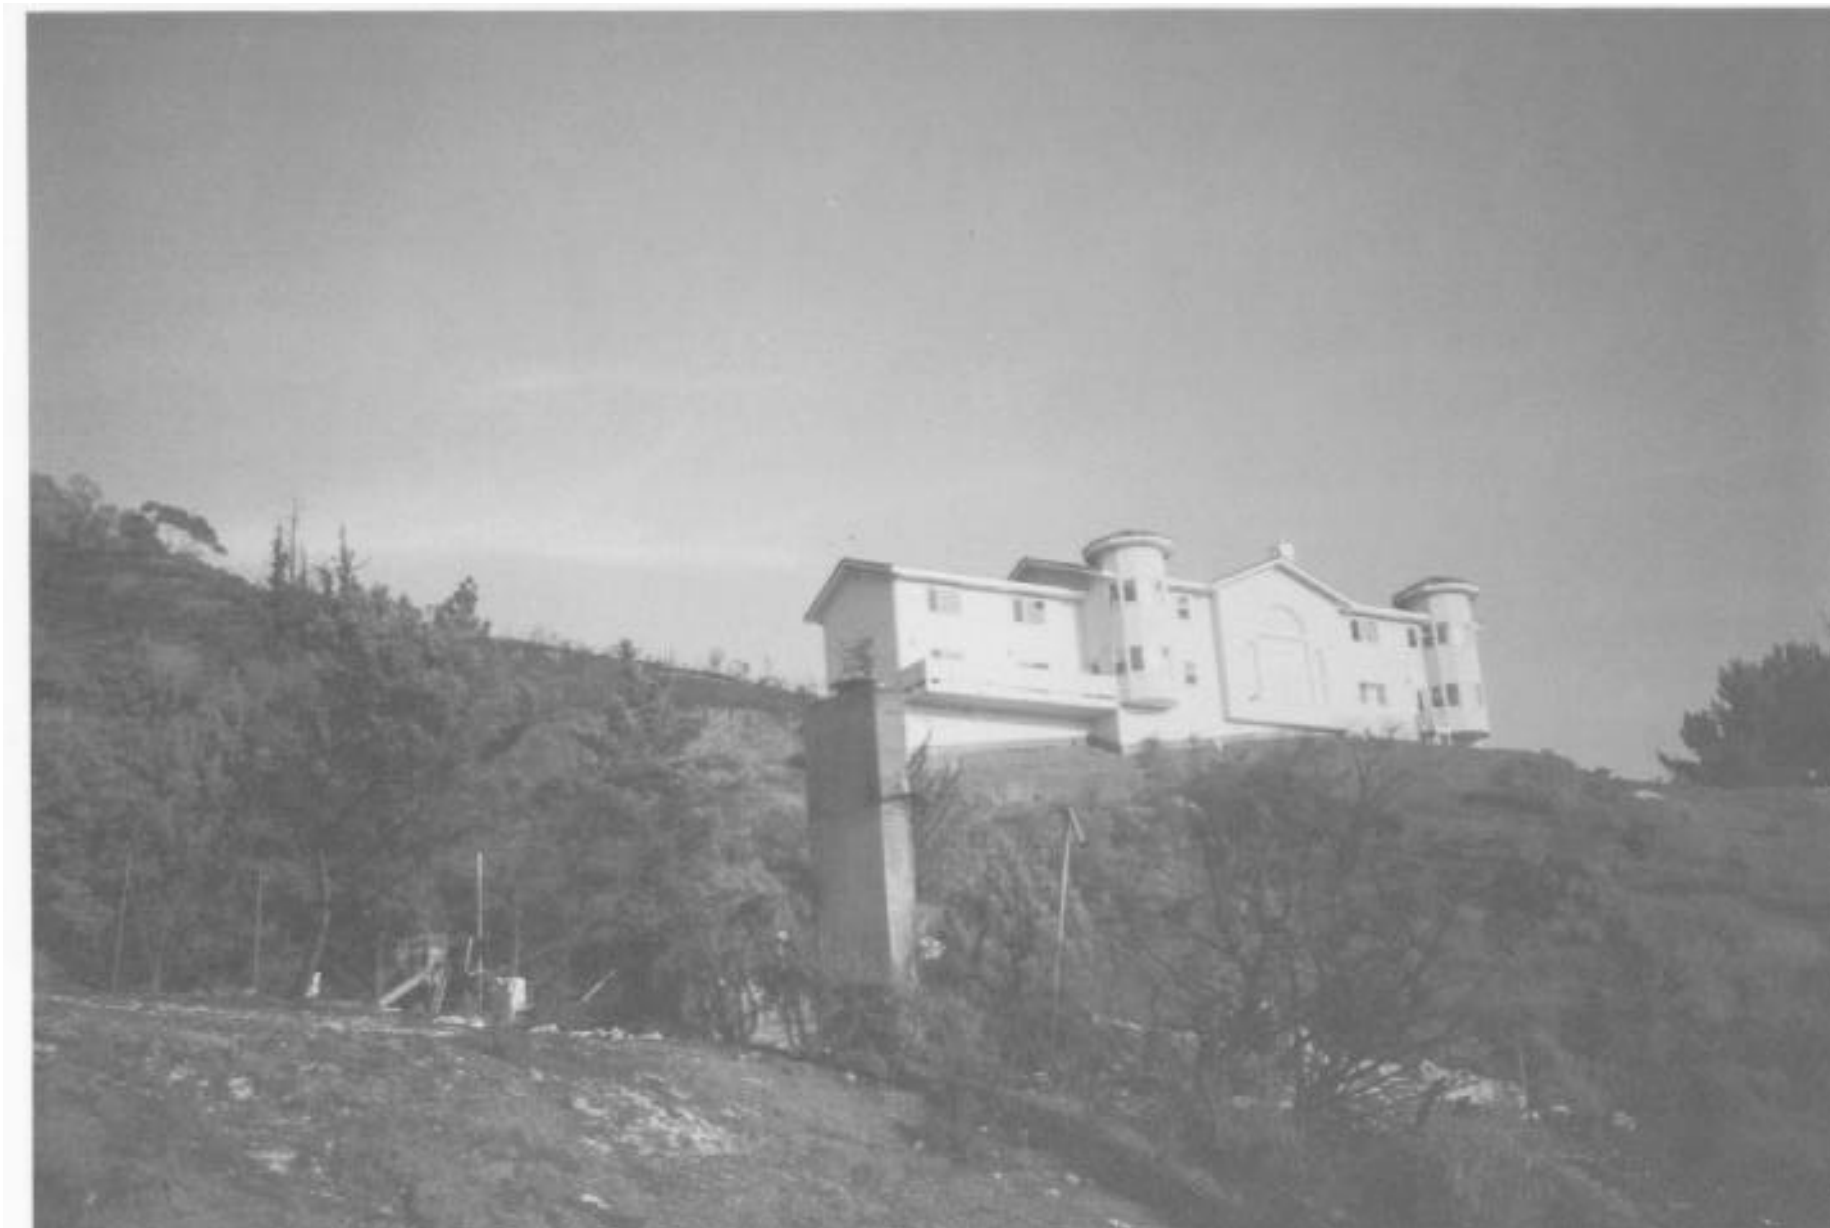
Large home saved by clear area around structure.

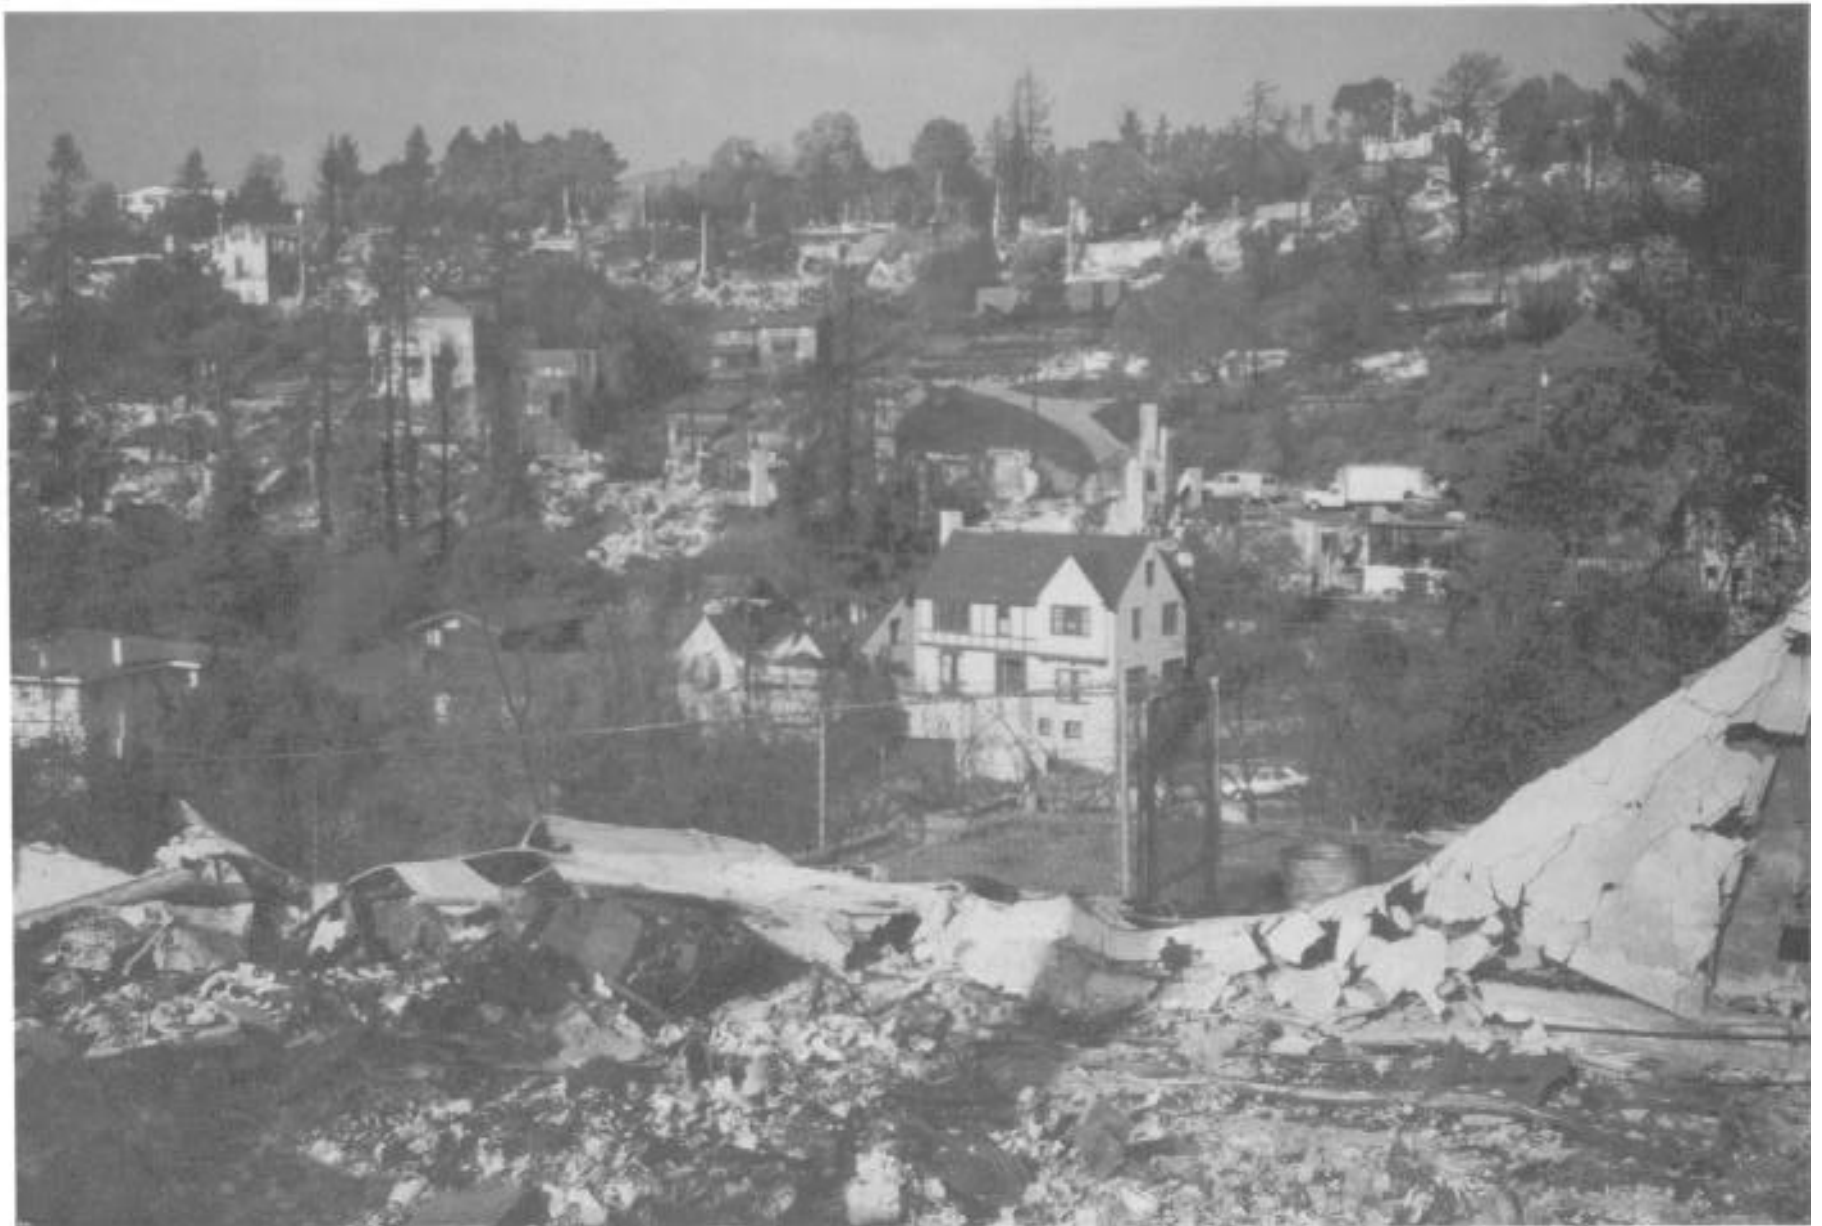
West limits of fire area - groups of homes saved, others lost.

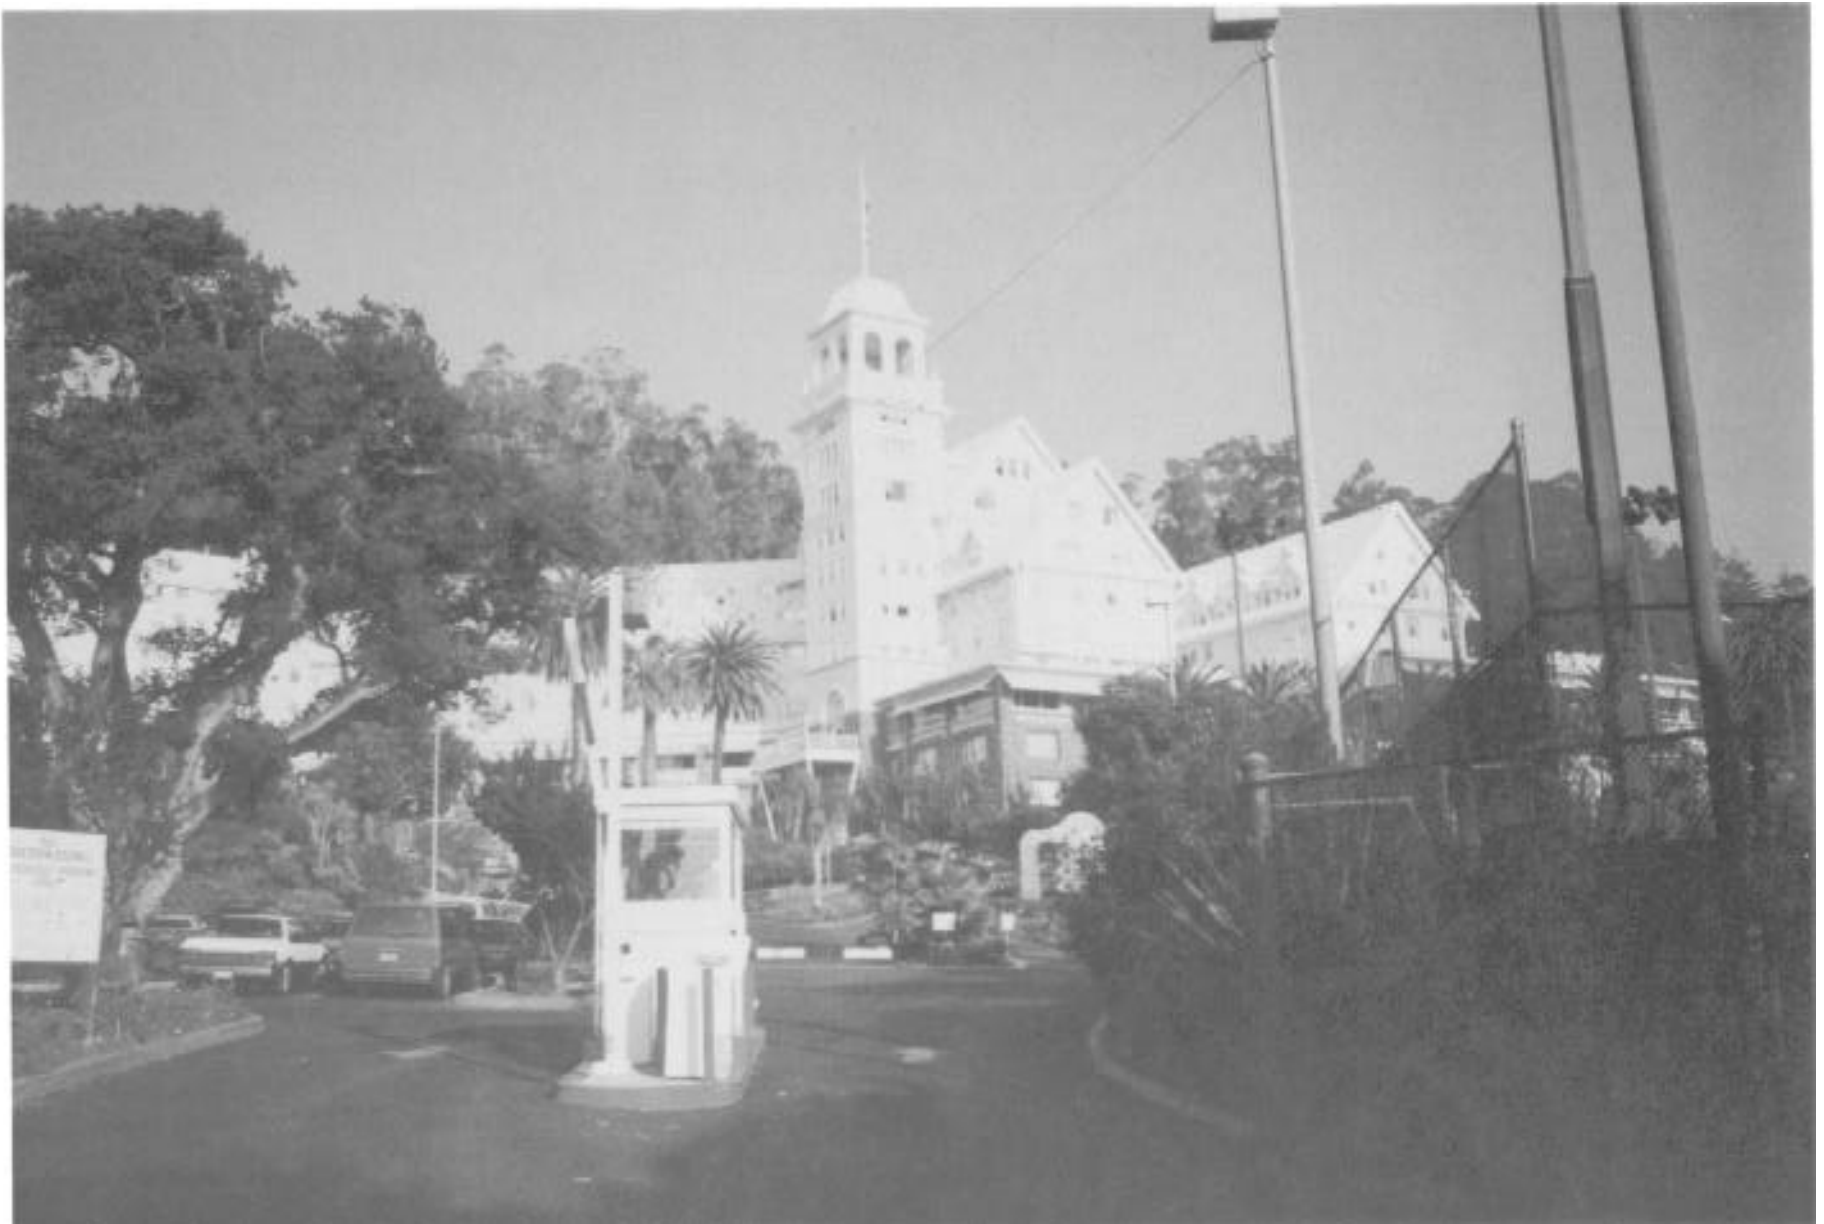
The Claremont Hotel - 5 - story wood frame structure in the path of the fire, considered a “conflagration breeder.”

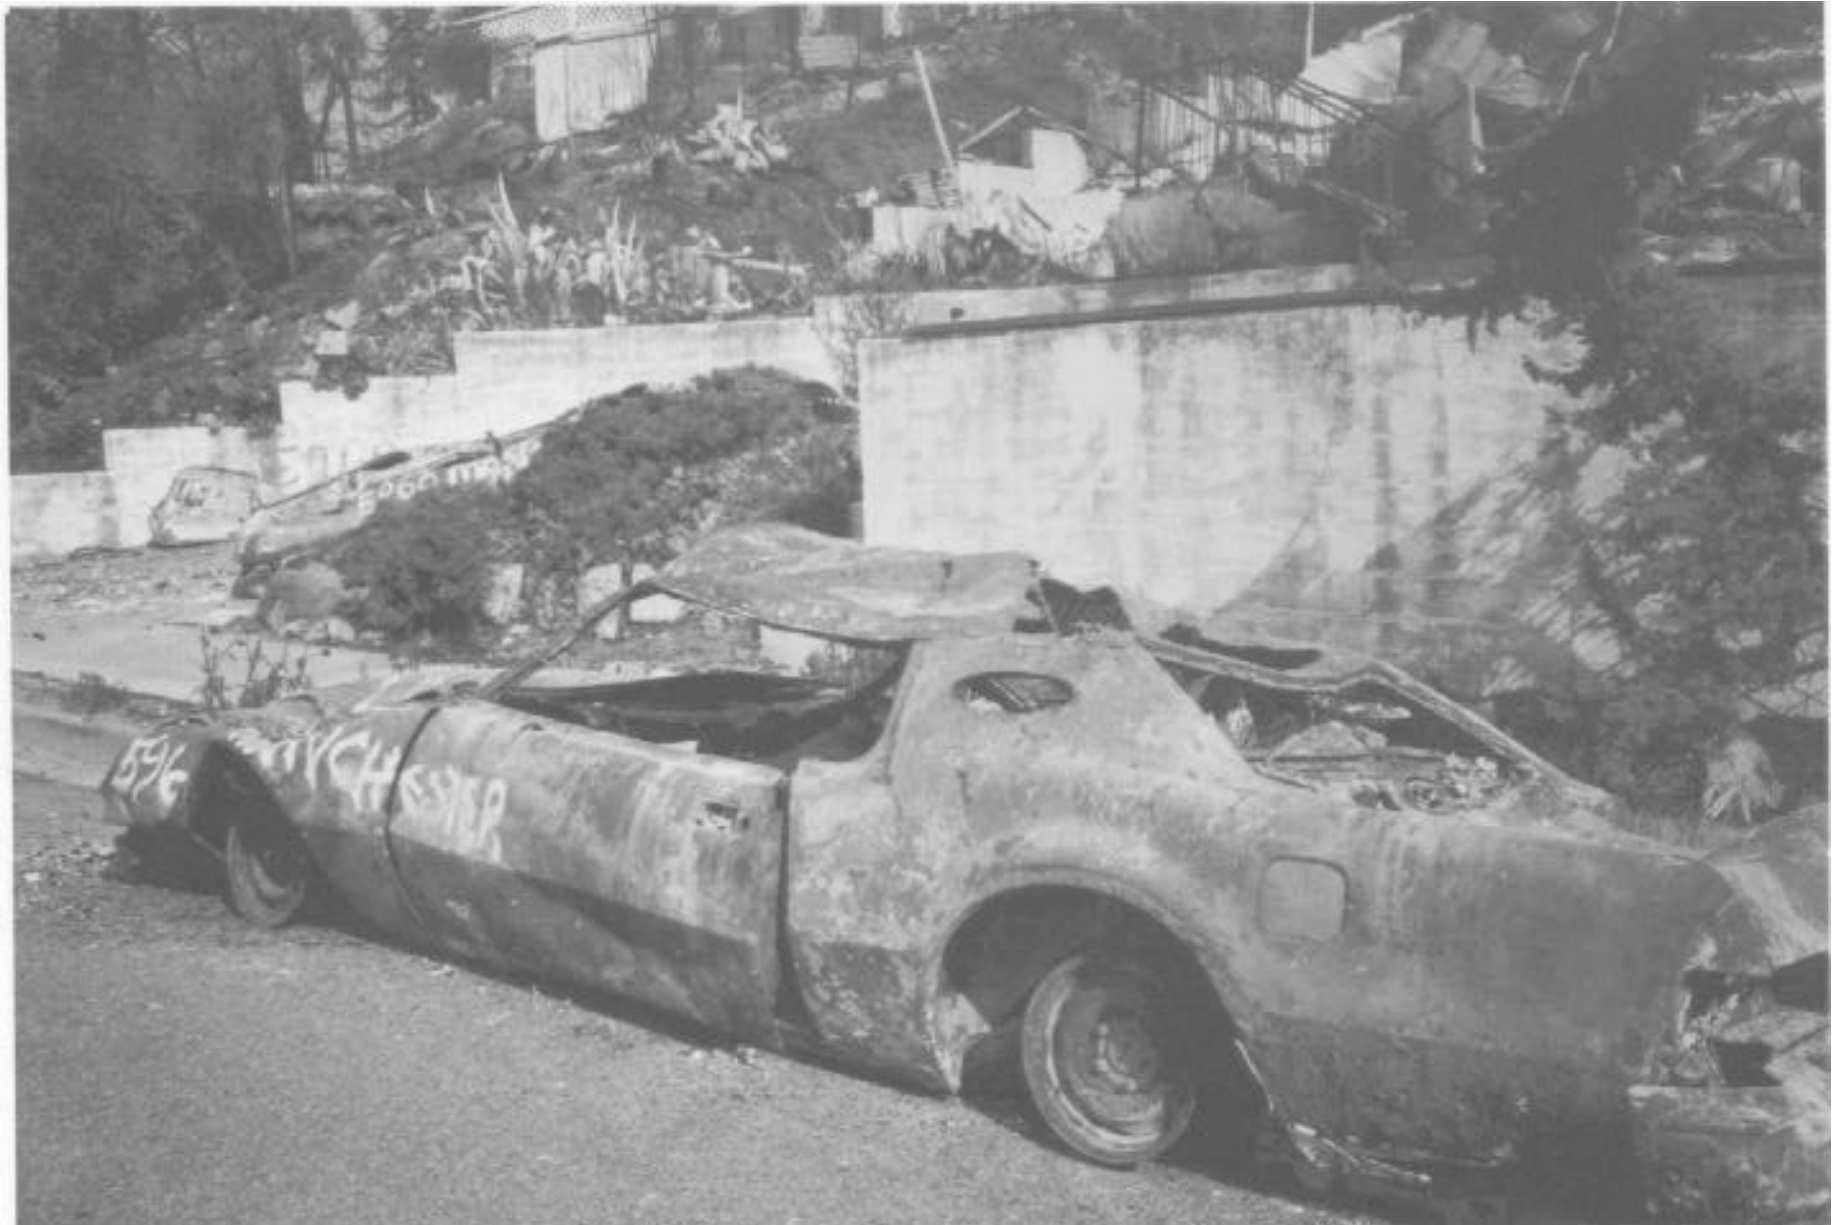
One of approximately 2,000 burned automobiles in the fire area.
